Improved Lubrication Practices Stop Machine Failures at TEP

Overview

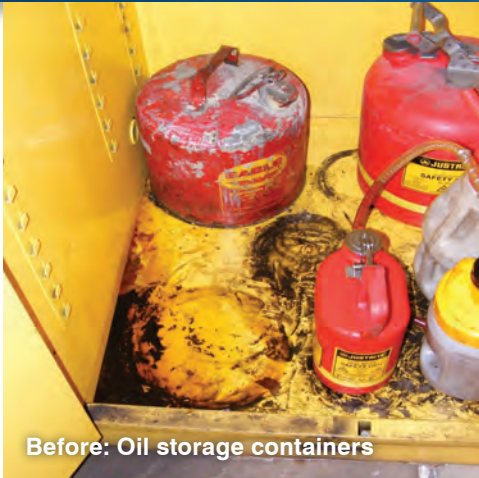
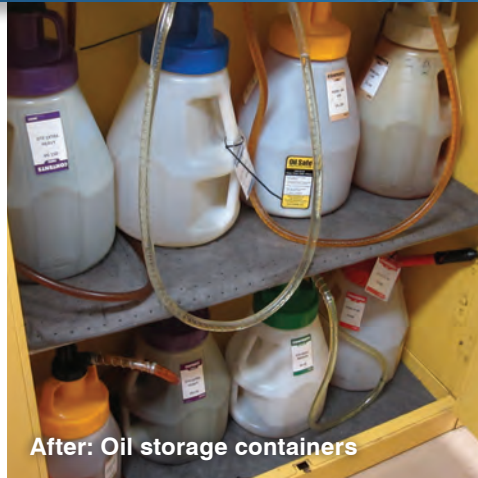
New master lube list

DTE 25	Tan
Heavy Medium	Grey
gear 600 XP 220	Black
as Mobilgear 630	Purple
gear 600 XP 460	Dark
as Mobilgear 634	Blue
gear 600 XP 680	Light
as Mobilgear 636	Red
DTE BB	
ela Super Cylinder	
W Cylinder	
Rarus 427

A master lube list was established with the correct oil types for all the station’s equipment, and new color-coded top-up containers were purchased. Each oil type would now have a dedicated pump and filter. Equipment was also tagged with color-coded labels that correspond to the appropriate transfer and storage containers.
