Improved Lubrication Practices Stop Machine Failures at TEP

Overview

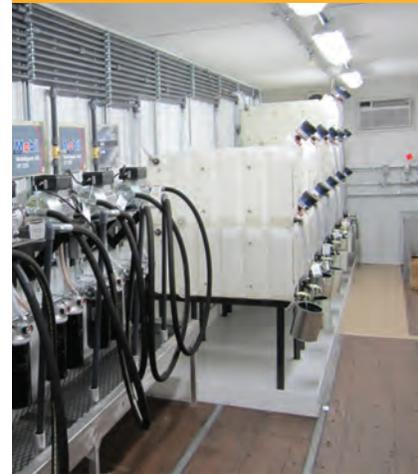
The TEP lube room

The biggest change for the plant was installing new self-contained lube rooms. These climate-controlled buildings would be used to store all the station’s oil. The oil would also be filtered going into the storage totes. After the first lube room was purchased, everyone in the plant received onsite training by PdM personnel, a lubrication engineer and Noria.

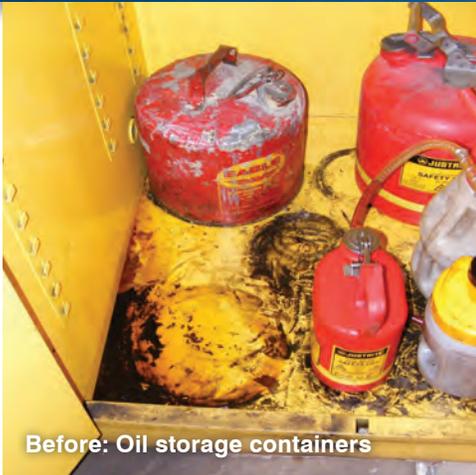
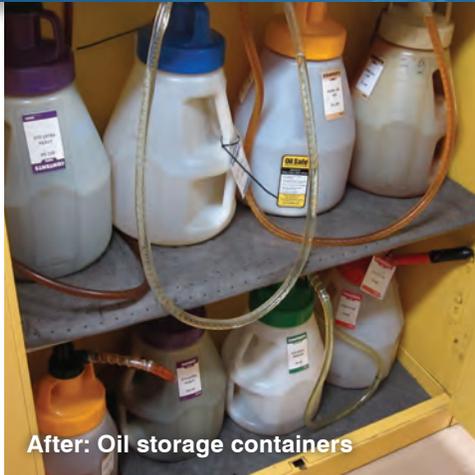
New master lube list

DTE 25	Tan
Heavy Medium	Grey
gear 600 XP 220	Black
as Mobilgear 630	Purple
gear 600 XP 460	Dark
as Mobilgear 634	Blue
gear 600 XP 680	Light
as Mobilgear 636	Red
DTE BB	
ela Super Cylinder	
W Cylinder	
Rarus 427

A master lube list was established with the correct oil types for all the station’s equipment, and new color-coded top-up containers were purchased. Each oil type would now have a dedicated pump and filter. Equipment was also tagged with color-coded labels that correspond to the appropriate transfer and storage containers.
