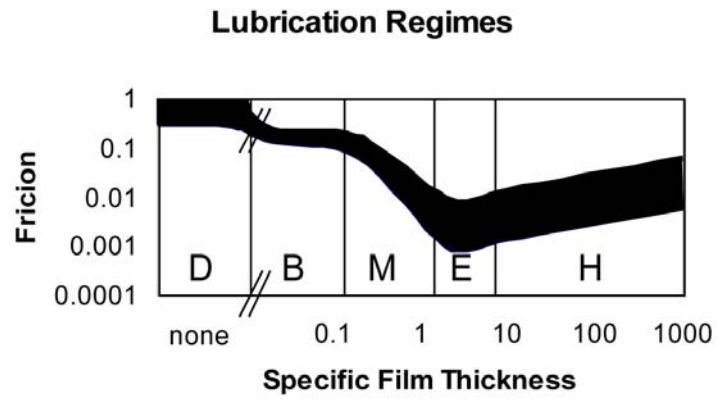
Figure 1. Coefficient of Friction as a Function of Specific Film Thickness.¹

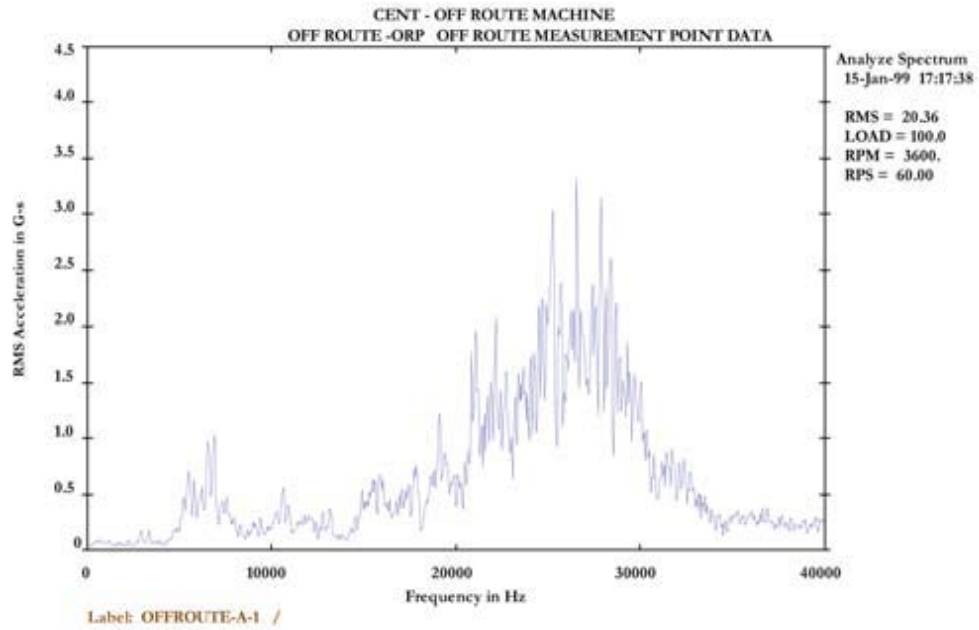
Figure 2. Frequency Domain from an Under-lubricated Bearing at Approximately 4,000 Revolutions per Minute²

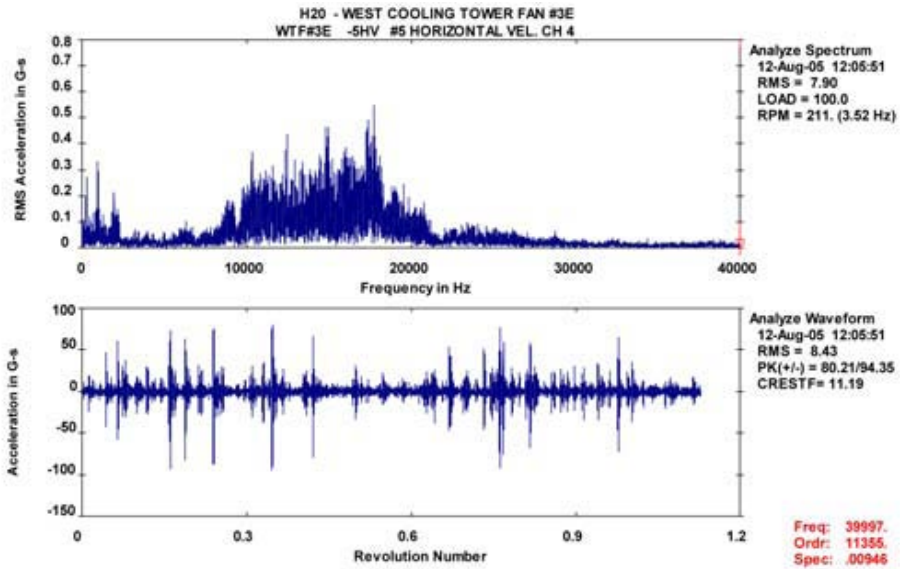
Figure 3. Frequency and Time Domain for a Gearbox Running with a Lubrication Fault

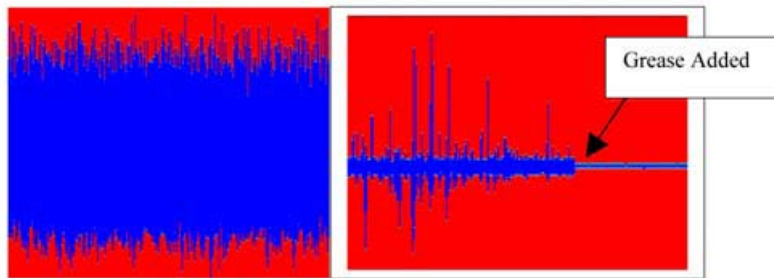
Figure 4. 30 KHz Heterodyned Sound Files Showing Progressive Lubricant Failure

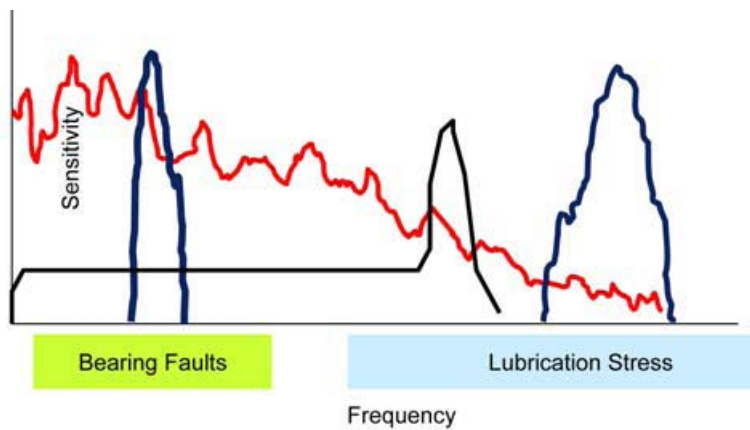
Figure 5. Sensor Sensitivity to Frequency Curves

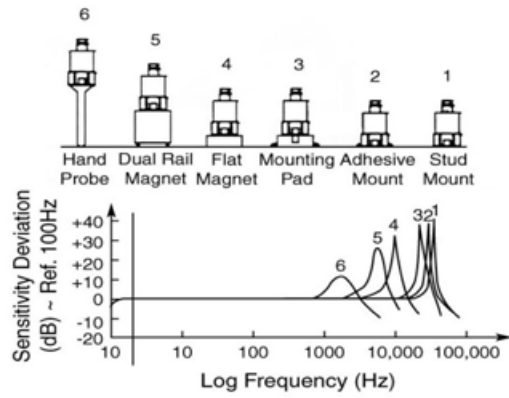
Figure 6. Effect of Accelerometer Mounting on Frequency Response

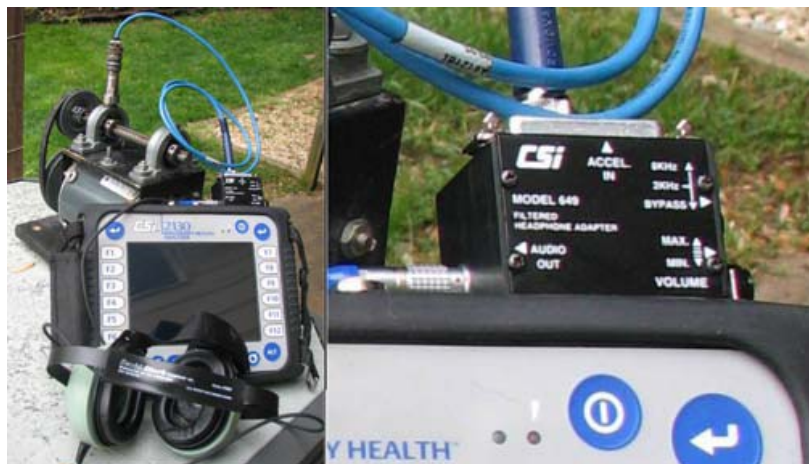
Figure 7. Vibration Analyzer with Headphone Output and Headphone Filtering

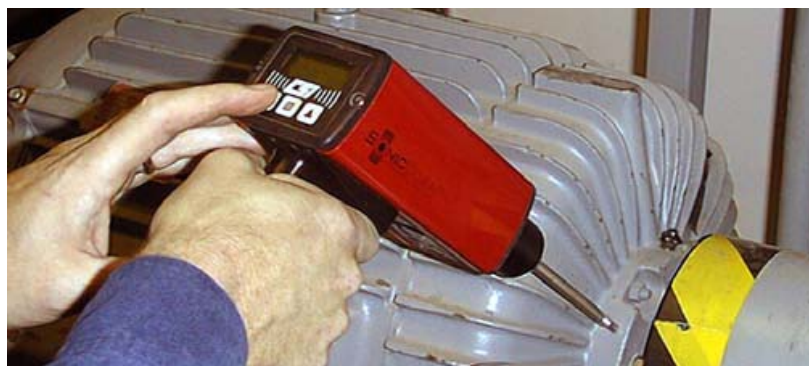
Figure 8. Ultrasonic Analyzer to Measure High-Frequency Lubrication Stress

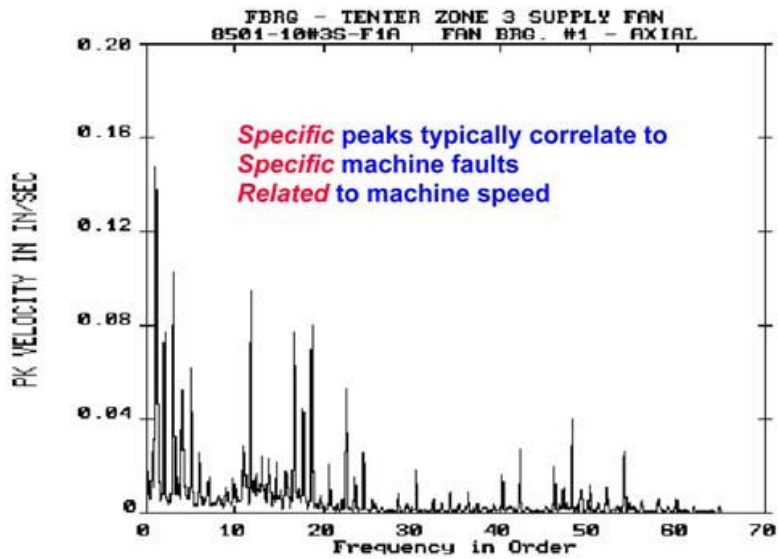
Figure 9. Frequency Domain Spectrum

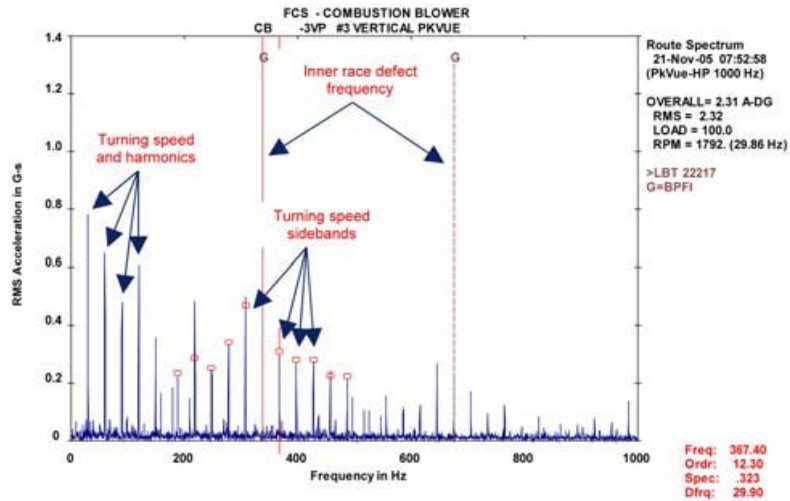
Figure 10. PeakVue Frequency Domain

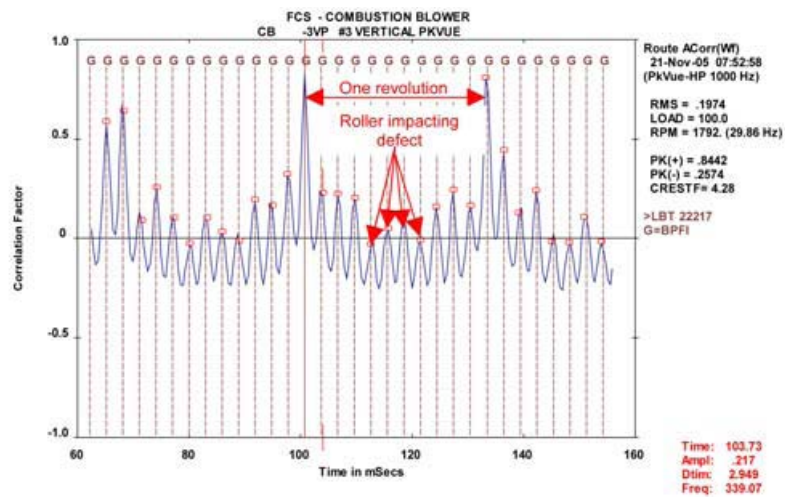
Figure 11. Autocorrelation of a PeakVue Time Waveform

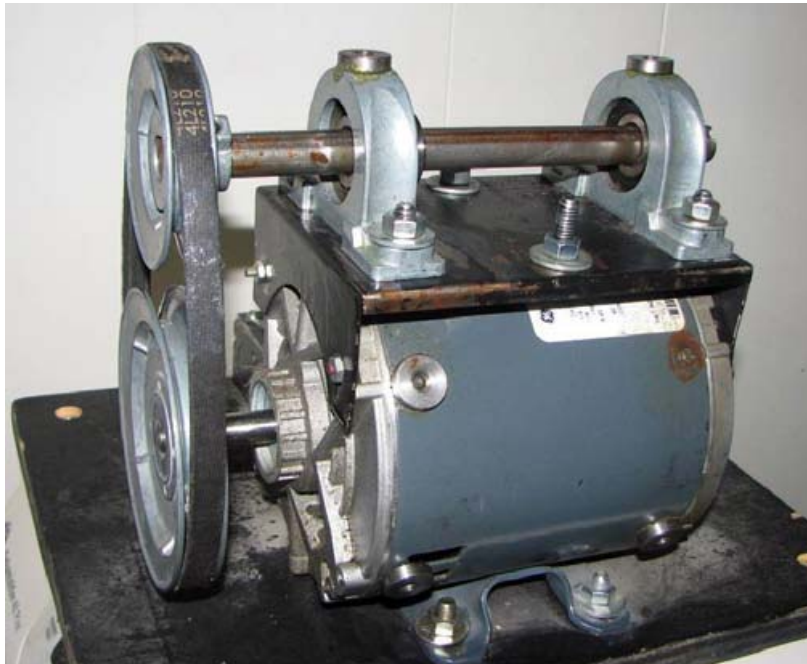
Figure 12. Test Motor – Top Inboard Bearing Monitored

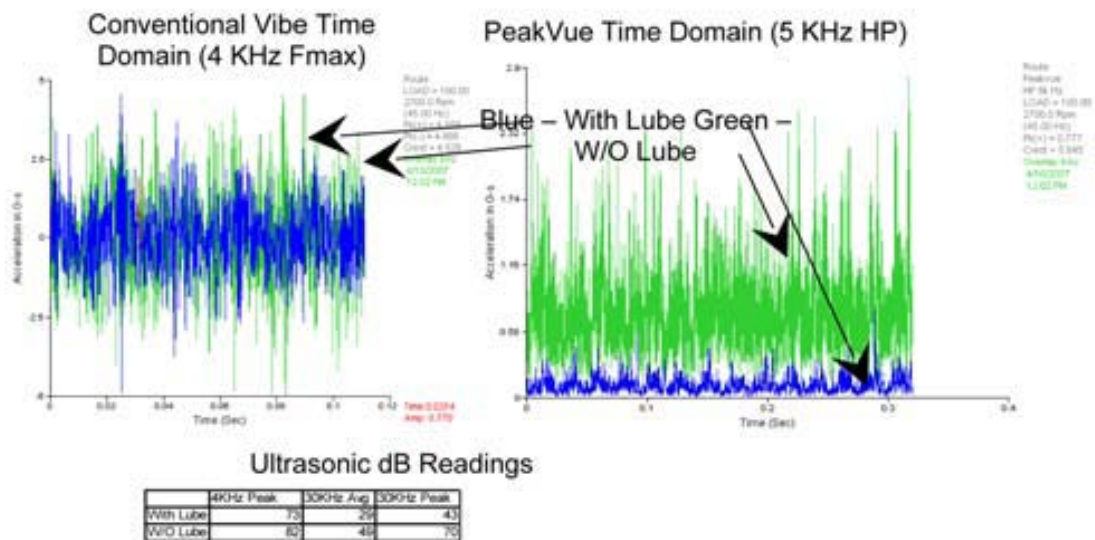
Figure 13. Time Domain Comparison

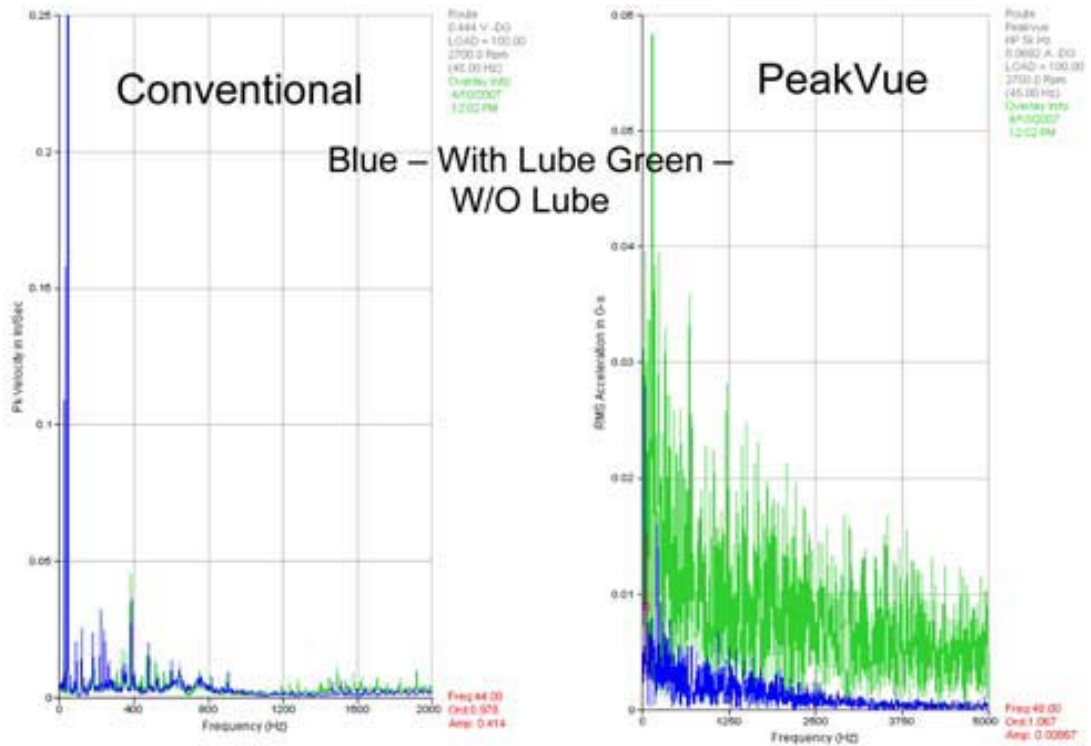
Figure 14. Frequency Domain Comparison

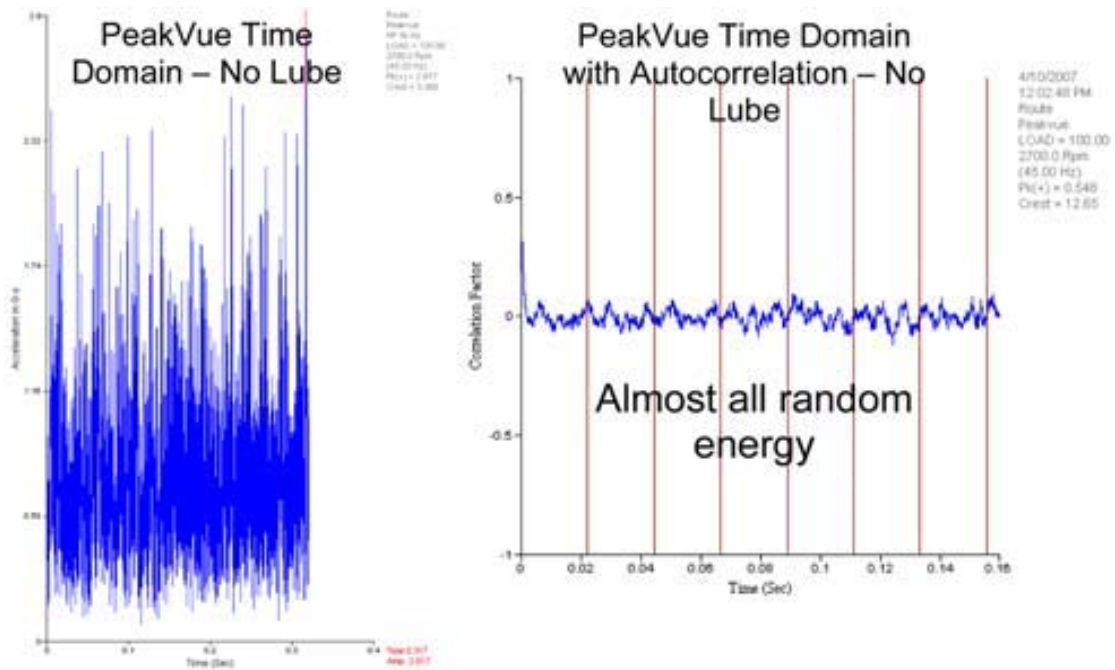
Figure 15. Autocorrelation of PeakVue Time Domain

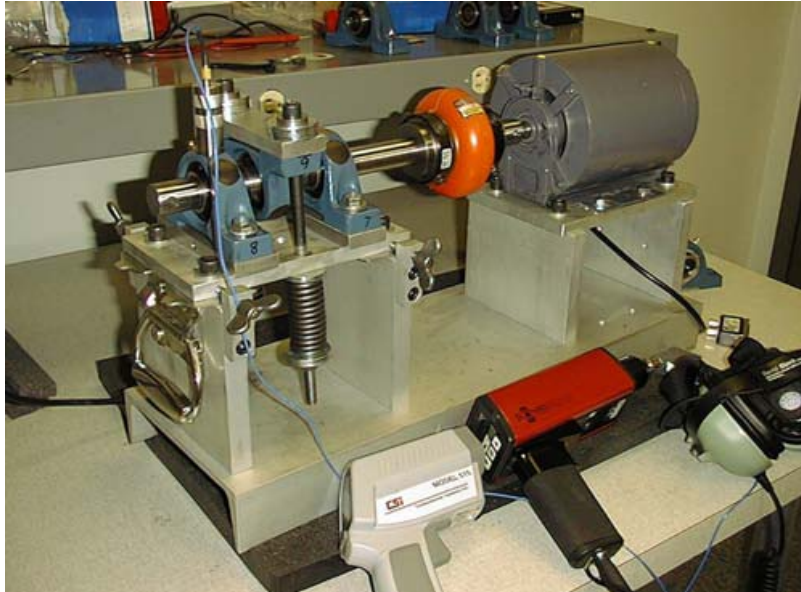
Figure 16. Lubrication Test Stand

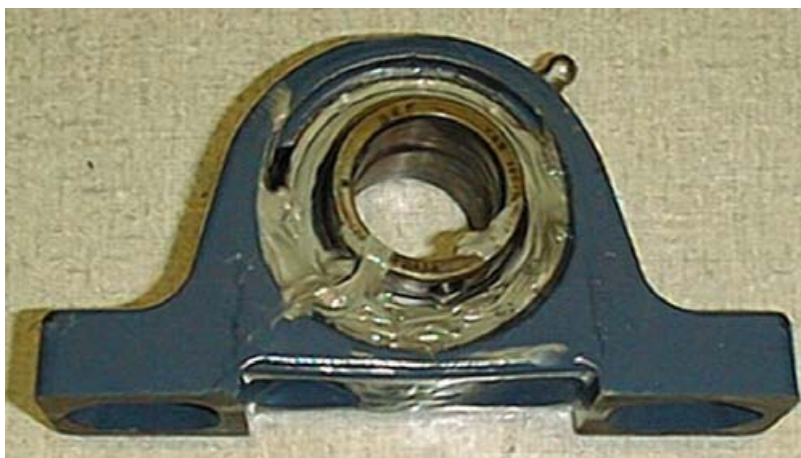
Figure 17. Over-greased Bearing

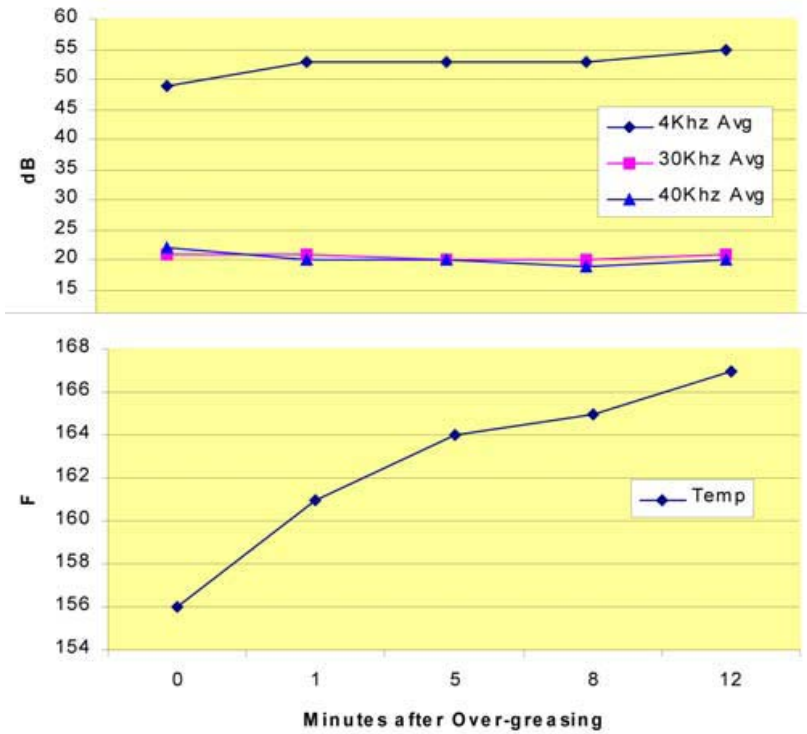
Figure 18. Effects of Over-greasing

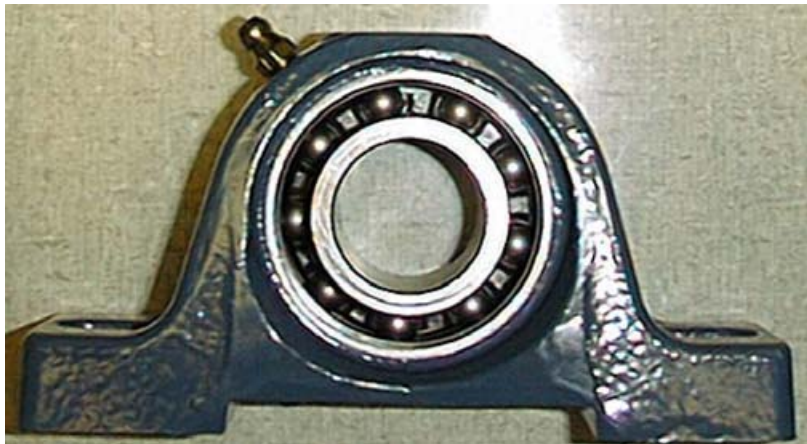
Figure 19. Bearing with Grease Removed

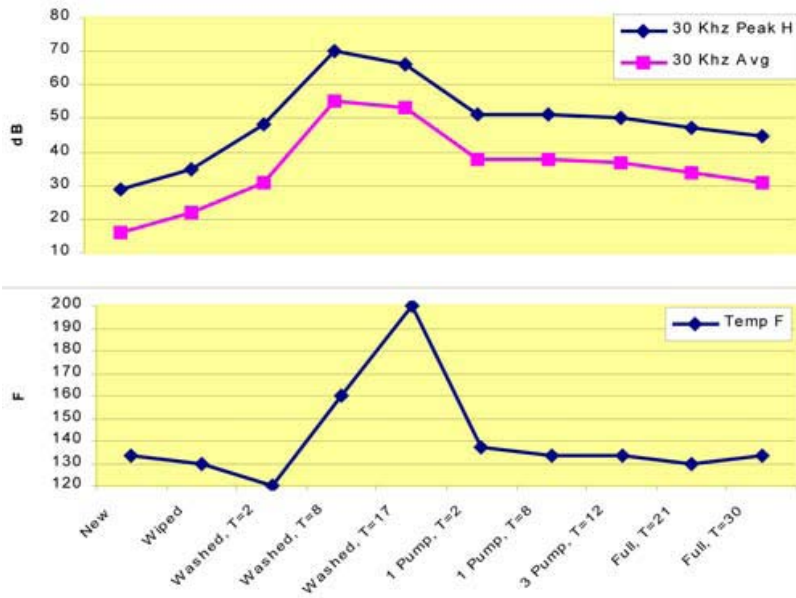
Figure 20. Under-lubrication and Re-greasing Results

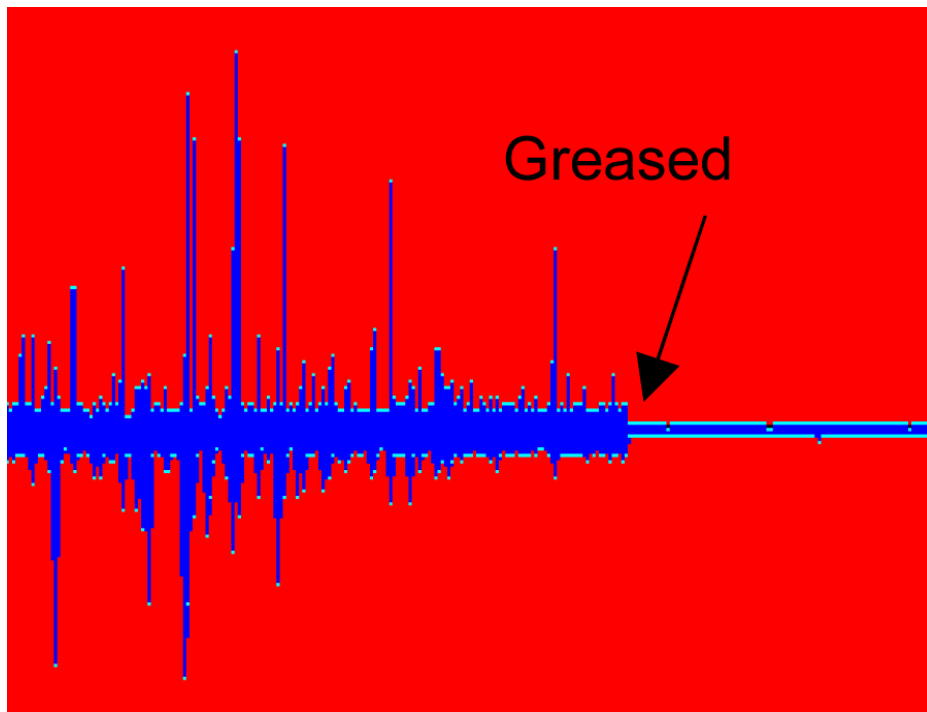
Figure 21. Sound Waveform Showing Decrease in Sound Level when Greased

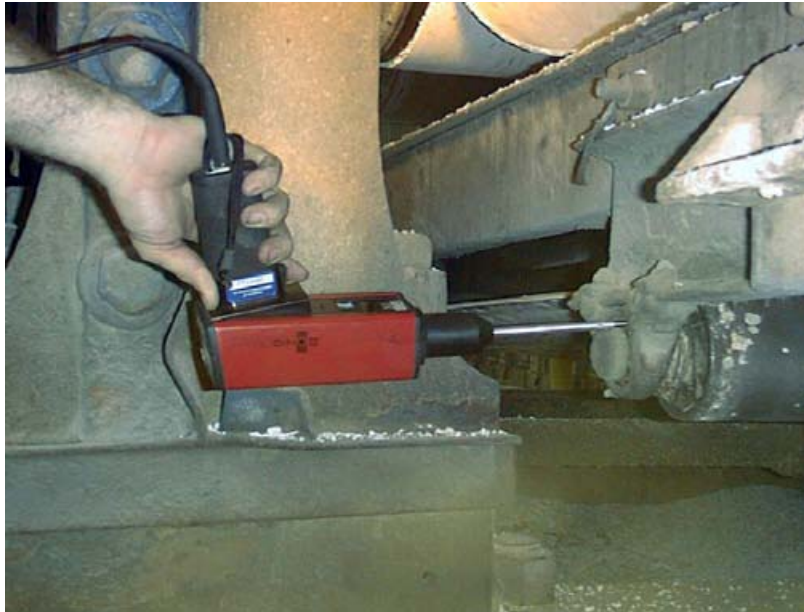
Figure 22. SonicScan with Contact Probe

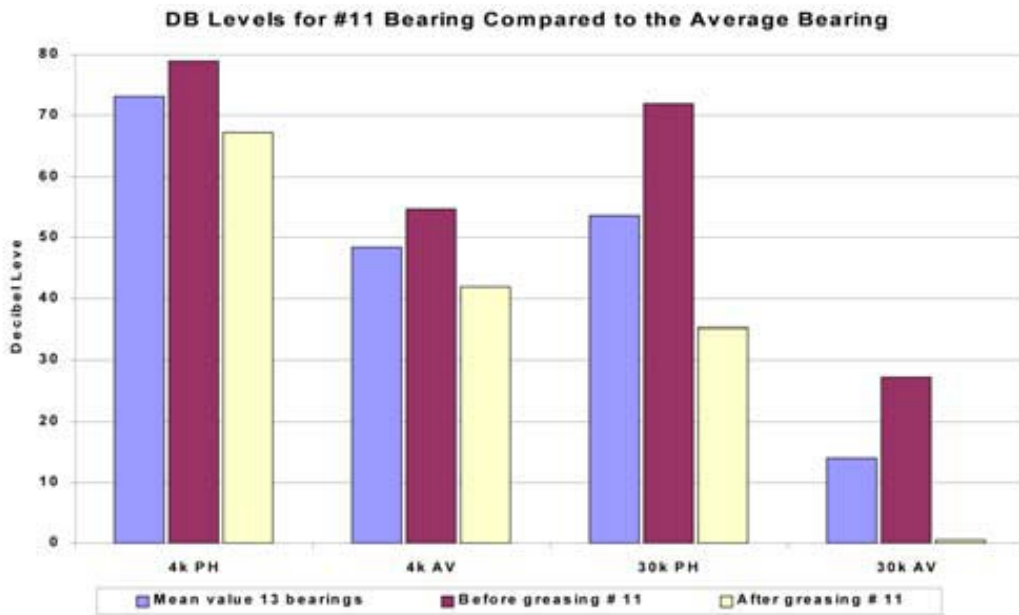
Figure 23. Conveyor Bearings Result³

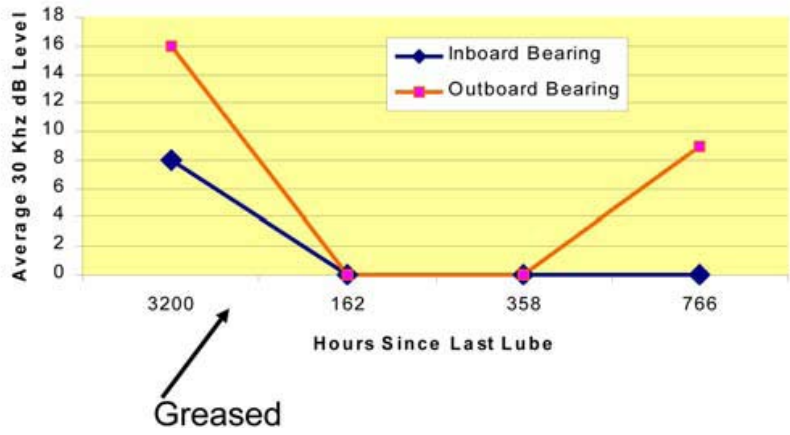
Figure 24. 75 HP GE Motor, Case 1

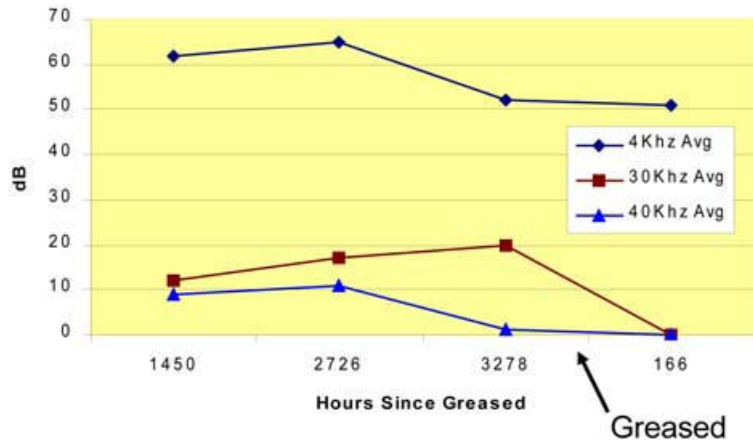
Figure 25. 75 HP GE Motor, Case 2

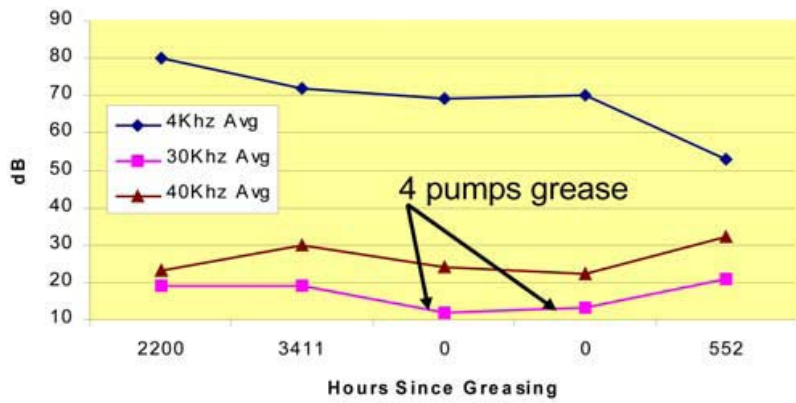
Figure 26. 450 HP Baldor Motor, Case 1

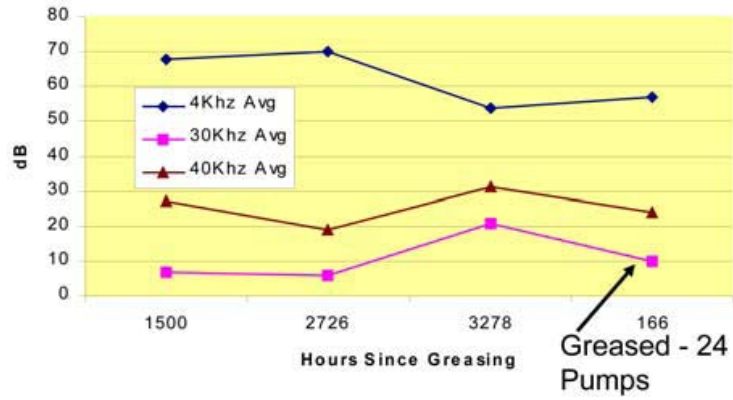
Figure 27. 450 HP Baldor Motor, Case 2

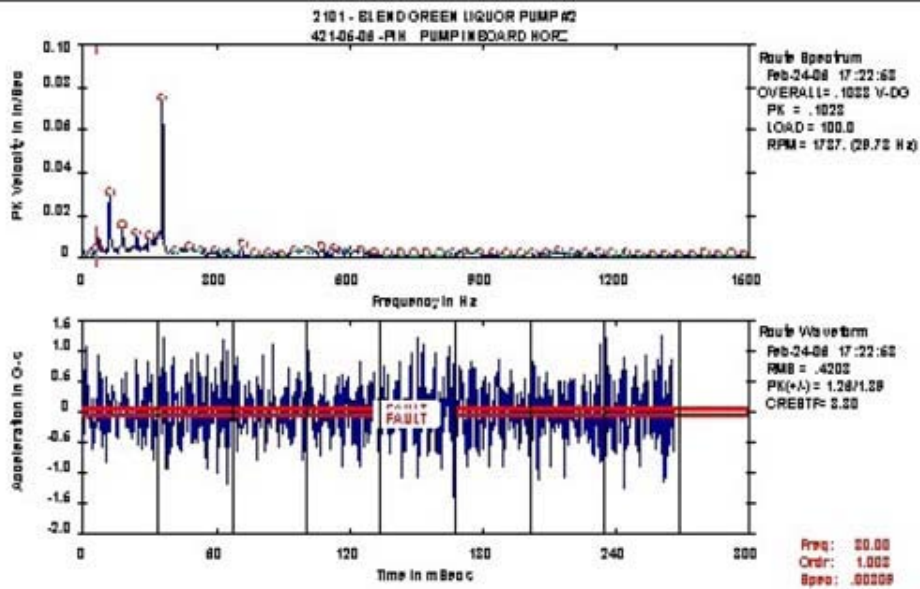
Figure 28. Conventional Vibration Data for a Pump

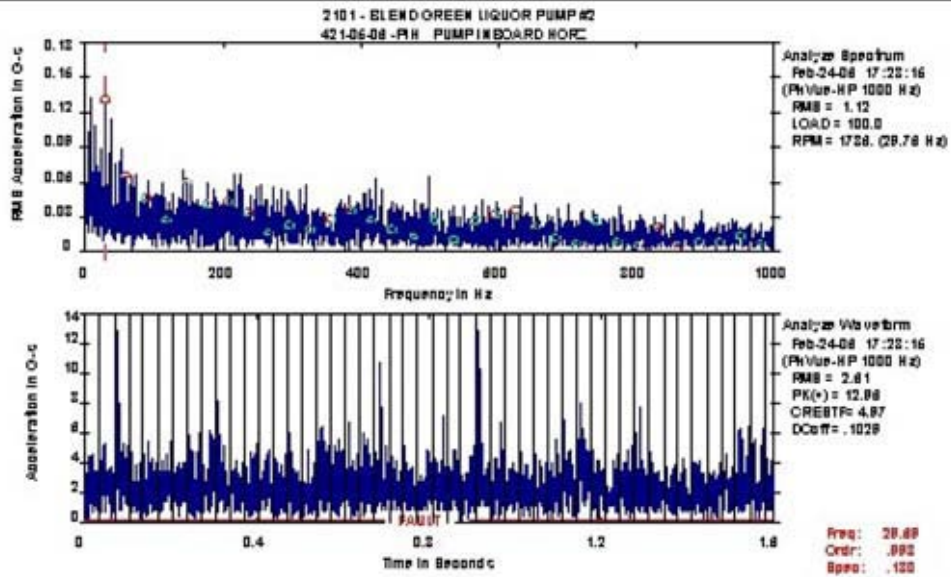
Figure 29. PeakVue Data for Pump

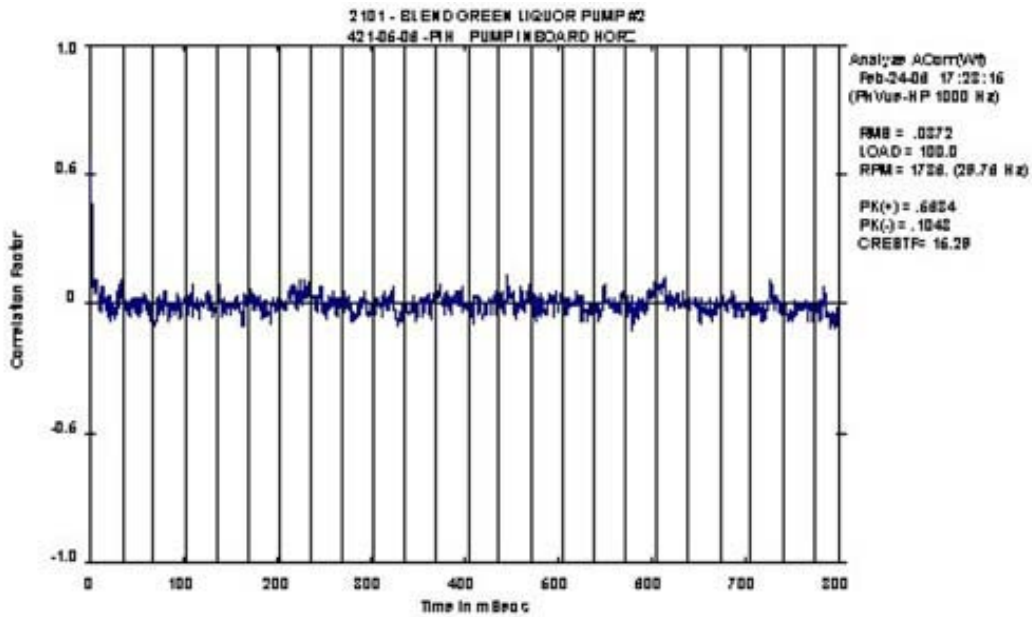
Figure 30. Autocorrelated PeakVue Waveform for Pump

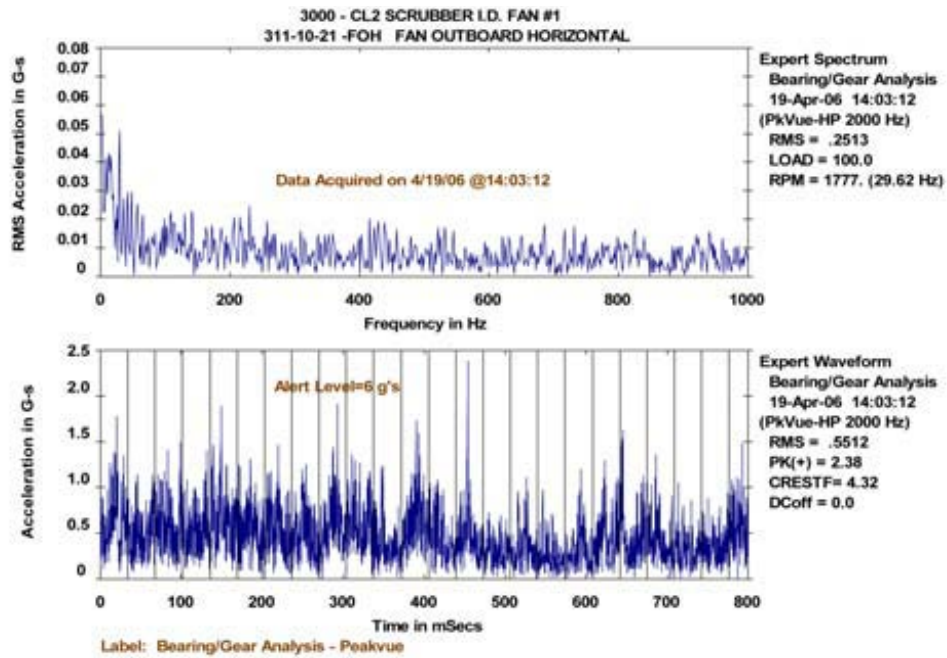
Figure 31. Scrubber Fan, April 19 PeakVue Data

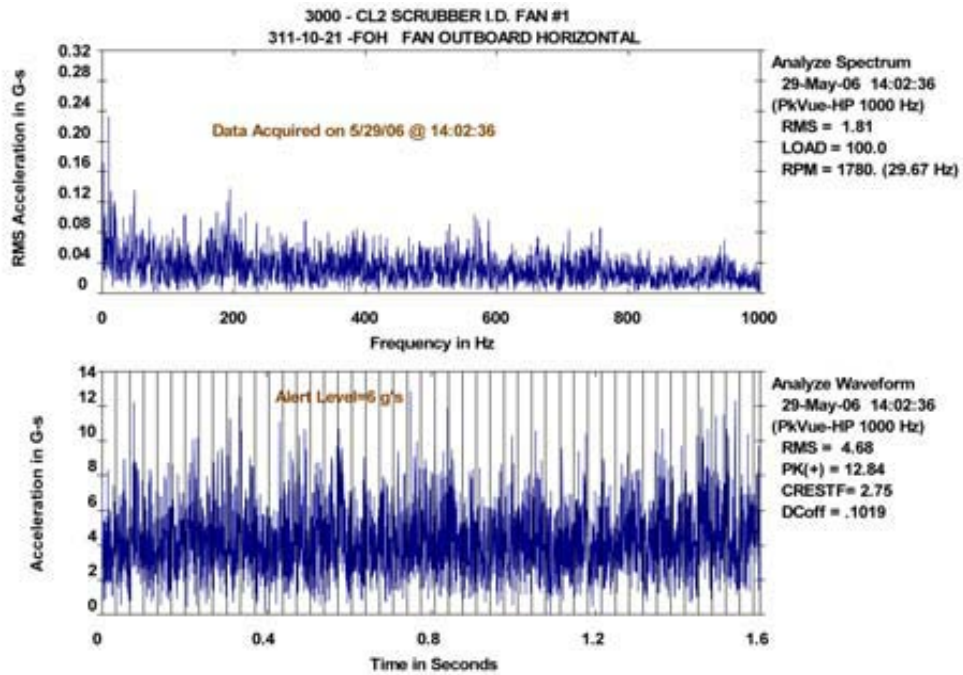
Figure 32. Scrubber Fan, May 29 PeakVue Data

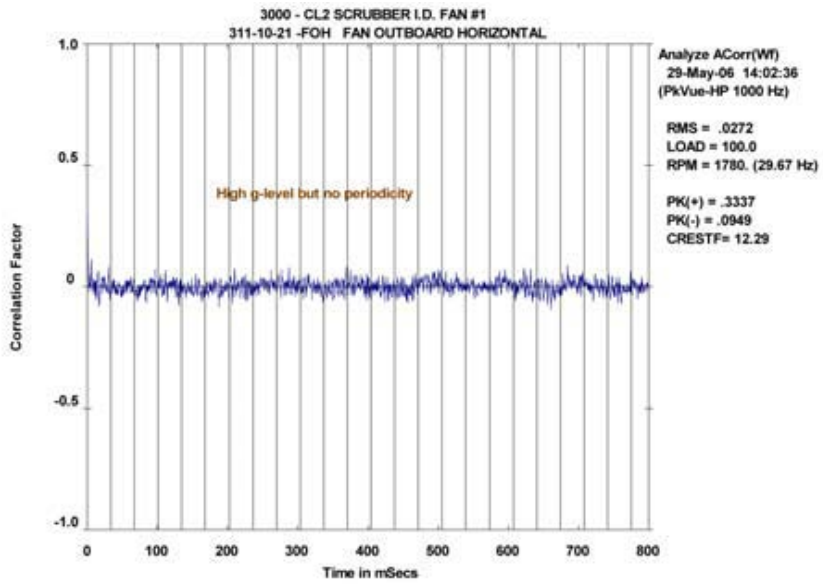
Figure 33. Scrubber Fan, May 29 Autocorrelated PeakVue Data

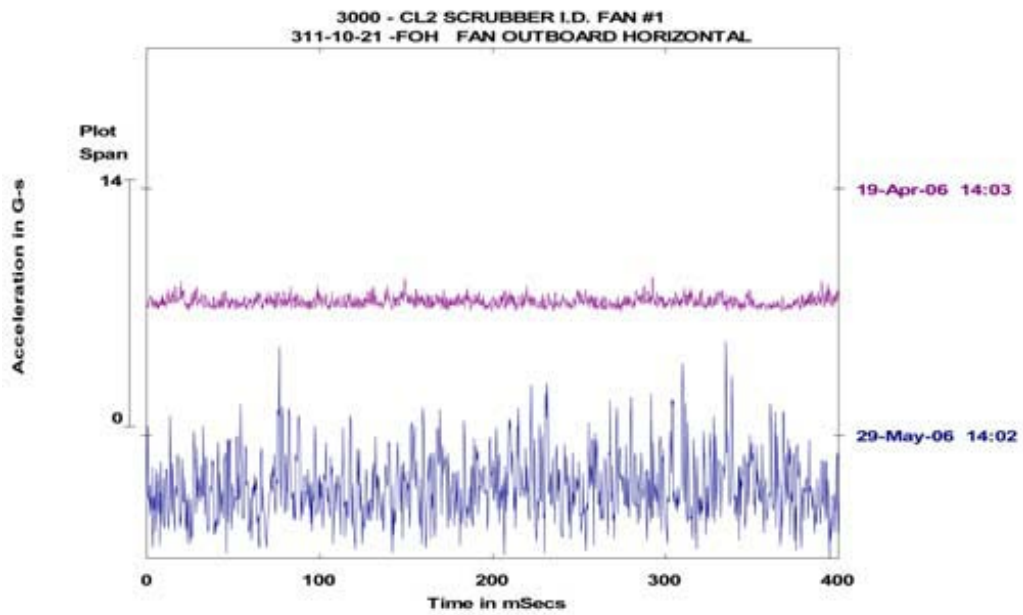
Figure 34. Scrubber Fan PeakVue Comparison

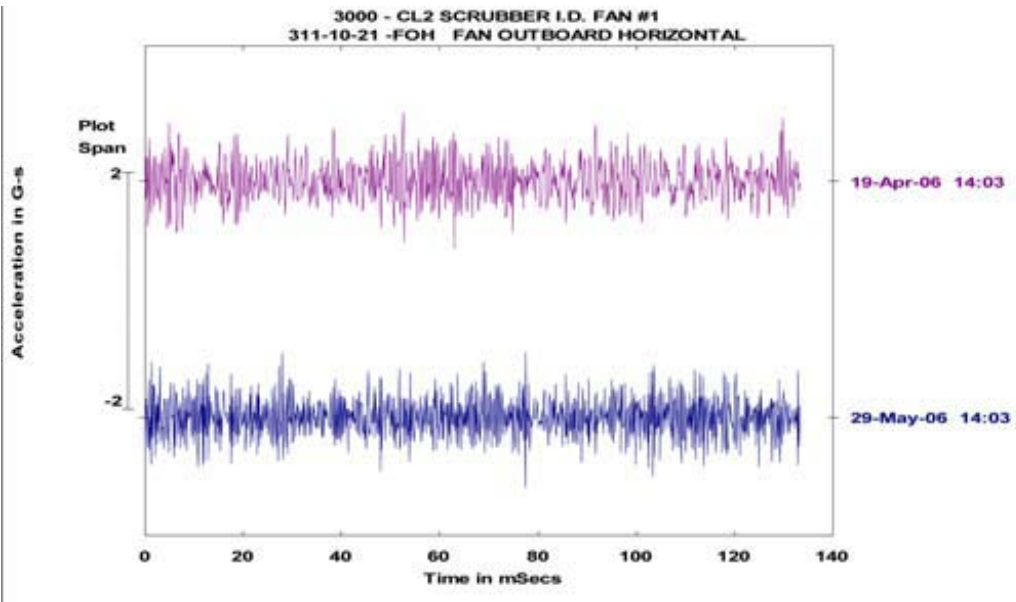
Figure 35. Scubber Fan Conventional Data Comparison

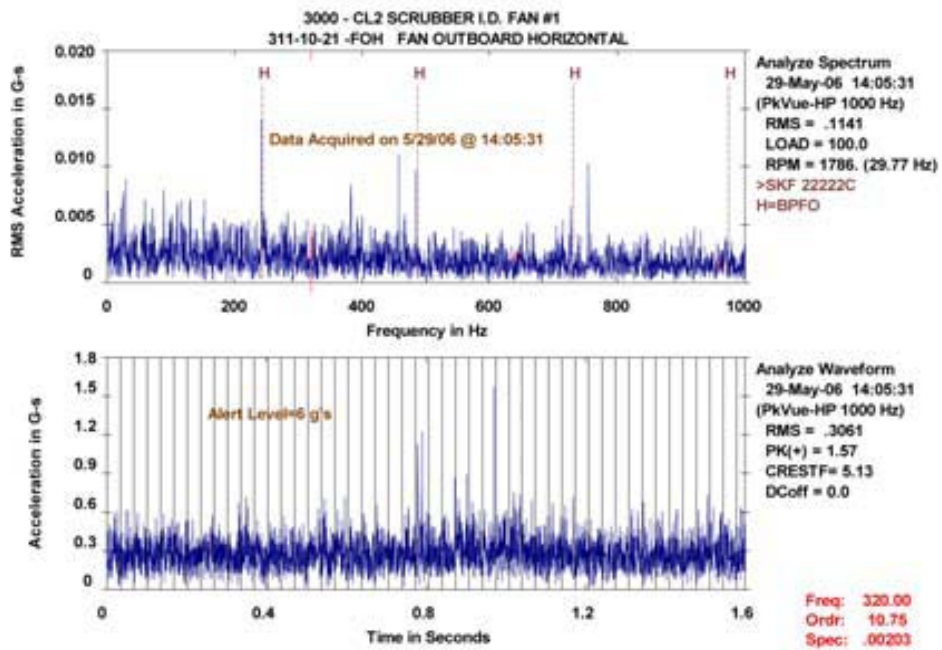
Figure 36. Scubber Fan PeakVue Data after Lubrication Problem was Corrected

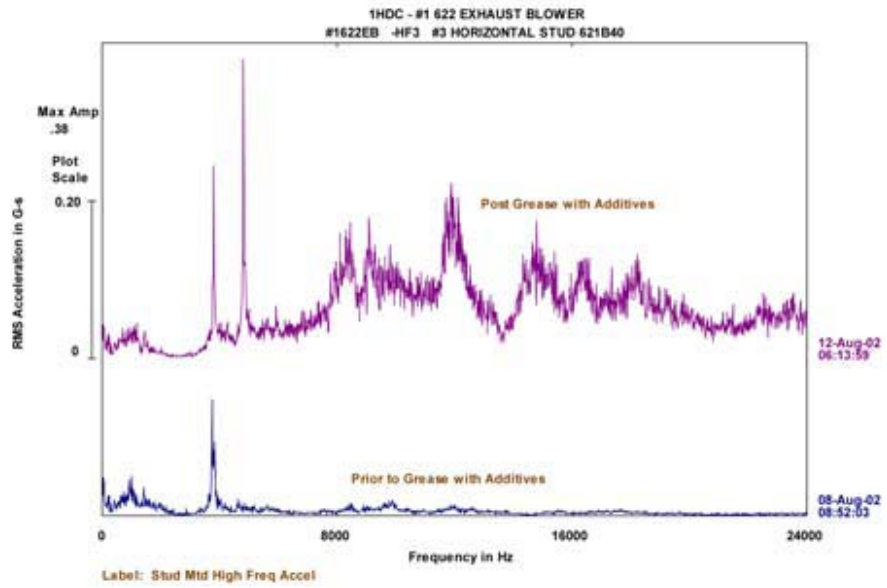
Figure 37. Exhaust Blower Frequency Data Domain Comparison

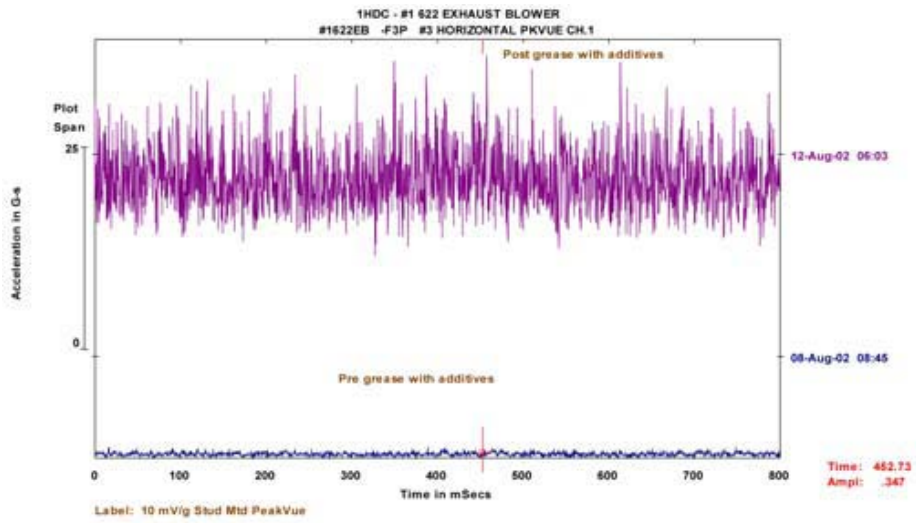
Figure 38. Exhaust Blower Frequency PeakVue Time Domain Comparison
