Keeping your Lubrication Program in the Crosshairs

An in-depth look at Luneta's Condition Monitoring Pod® (CMP®) and how it can improve your lubrication program.

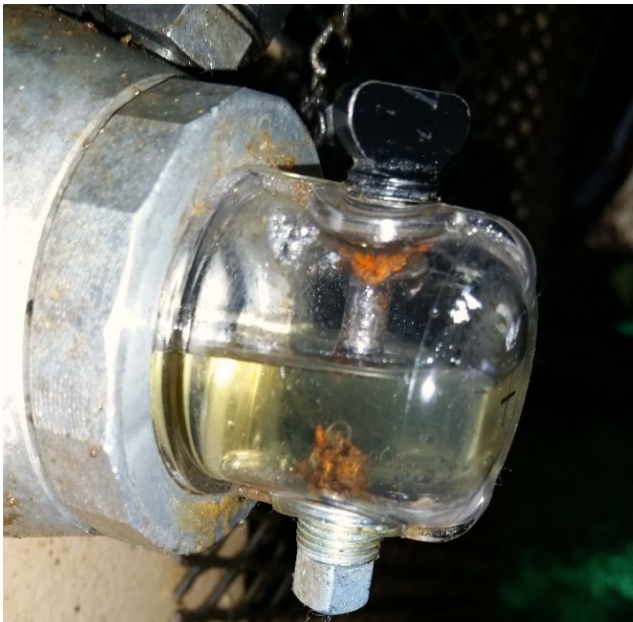
This CMP at a food processing plant is indicating water contamination. Notice the rust on the steel corrosion indicator at the top of the sight glass. Fluctuations in oil level have caused some of the rust to break off and be captured by the magnet below.

The CMP can expose the presence of even small amounts of water, both visually and through its corrosive properties using a steel corrosion indicator. The CMP's indicator is suspended and visible inside the sight glass. This indicator is primed for corrosion and will generally rust before exposed surfaces inside the machine. When water is present, the indicator corrodes and changes in color from shiny metallic to black or orange. This change is visible through the sight glass and can be easily observed during daily inspections. Rotating the sight glass also lifts the indicator out of the oil for cleaning and closer inspection without the risk of losing oil.

A rusted steel indicator is an alarm that water is present and that the risk of corrosion inside your machine is very high.

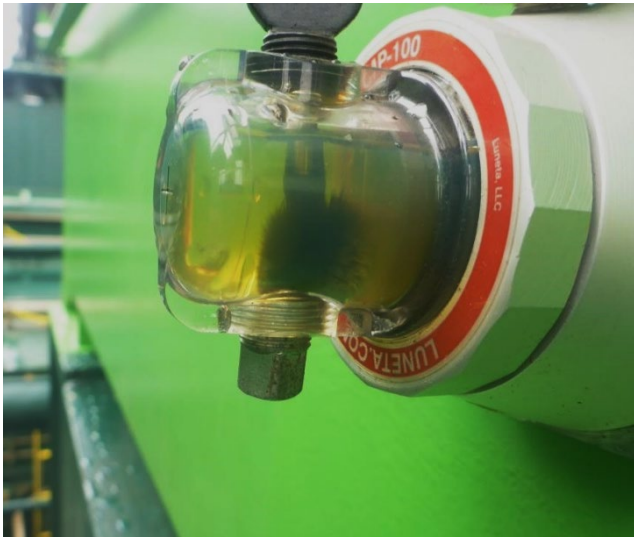
The CMP in this photo is on an ocean dredging vessel and is displaying a collection of wear debris on its magnetic plug.

The CMP features a magnet suspended inside the sight glass for real-time observation of wear debris collection. The magnet should be observed daily for any changes. It's typical for

small amounts of debris to collect over time – the magnet is helping to remove iron and steel particles from the oil. However, when there is a sudden increase in the amount of collected ferrous metal, abnormal wear is occurring, and machine failure is impending.

When the magnet becomes full, rotating the sight glass lifts the magnet out of the oil for further analysis and cleaning. Wear debris analysis helps determine where and how the ferrous particles were generated. Most oil testing labs are equipped with instruments and software for analyzing wear debris.

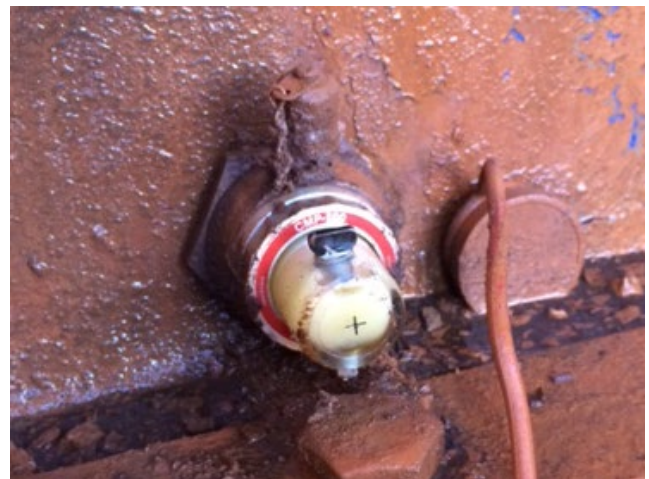
This CMP Sight Glass on a gearbox at a mine is indicating air contamination by foam on the surface of the oil.

The CMP's 3D sight glass is beneficial in identifying air contamination. Entrained air will cloud the oil inside the sight glass, and foam will rise to the surface, if not fill the entire sight glass. Both of these conditions are easily observable during daily inspections.

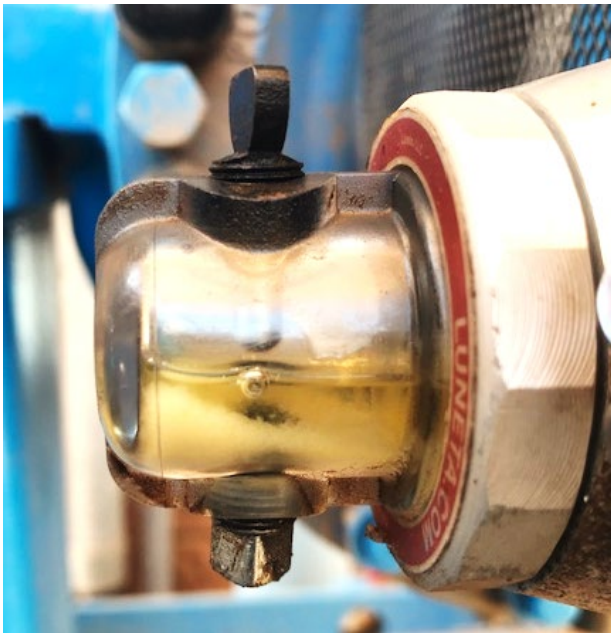
A mysterious white substance is being indicated by the Condition Monitoring Pod at a water reclamation facility in Arizona.

One such example involved a pump at a water reclamation facility in Arizona that utilizes over forty CMP's. During a routine inspection, a technician noticed an opaque white substance in the sight glass. The technician rotated the sight glass to agitate the substance and concluded it was gelatinous in nature and suspended within the oil. A sample was taken using the convenient sampling valve and the lateral ports on the sight glass; however, lab analysis was inconclusive. Further investigation revealed that a PTFE oil slinger had been improperly installed and was wearing severely. The wear debris from this

slinger was what had produced the white gelatinous substance captured and displayed by the CMP. Had it not been for the CMP the oil slinger would have ultimately failed, leading to a more catastrophic and more costly failure of the pump.
